# MOISTURE MANAGEMENT™

## Moisture Management Quarterly

JULY 2008

VOLUME 2, ISSUE 5

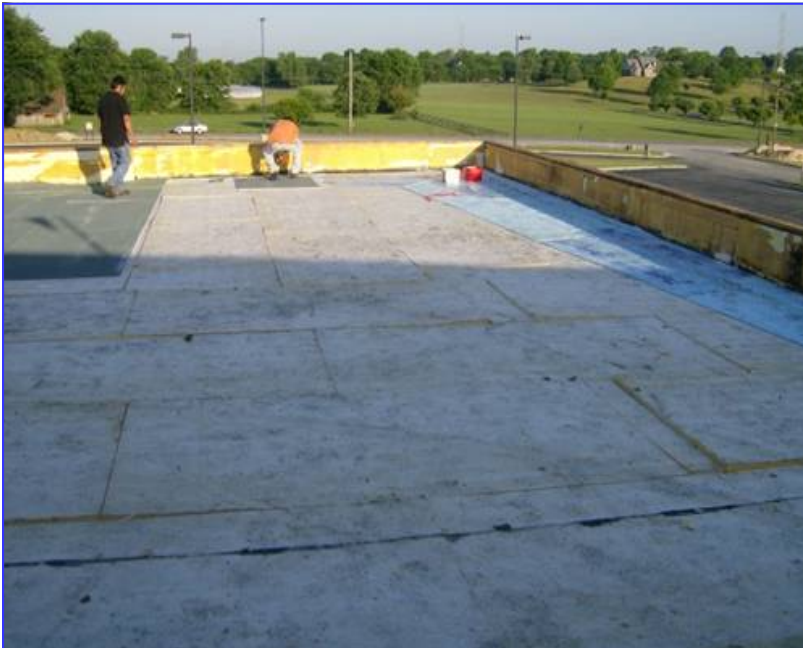
The photo on the right shows a re-roofing job in progress over an pre-existing roof membrane. After the roof was scanned with an infra-red camera, the substrate was found to be dry and in good shape. Therefore, roof tear off was not needed and the remaining "R" value of the insulation was salvaged at a great savings to the customer. The lack of tear off also shortened the completion time and reduced construction mess and building disruption.

New advances in technology, particularly in the areas of infra-red and nuclear scanning, provide roofing consultants with the ability to much more accurately evaluate roofs and determine, before tear off, what percentage of the underlayment is saturated and will need to be replaced. In one specific case, Moisture Management was able to save a client over \$100,000 dollars by performing these scans and recommending a scope of work to re-use salvageable insulation.

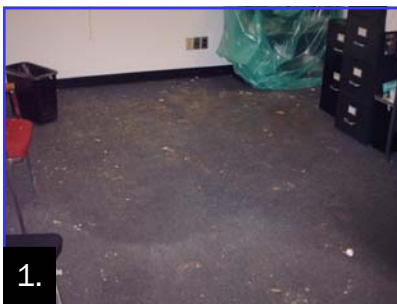
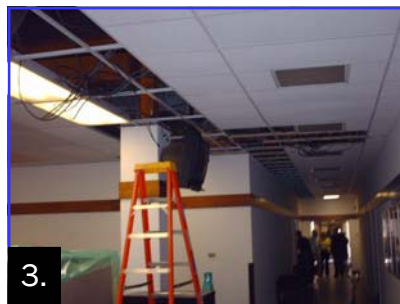
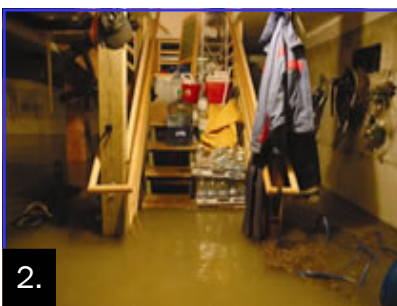
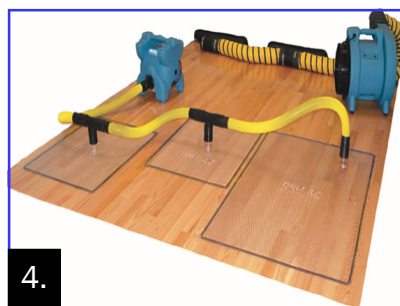
### Photo Log:

- 1). Class I water damage on floor
- 2). Class II water flooding in basement
- 3). Class III damage from ceiling above
- 4). Class IV remediation, drying a hardwood floor

The first step any professional restoration firm will do is both classify and categorize the water intrusion in scope and severity. Typically there are four classifications of severity in water damage cases:

- Class I Damage—water intrusion is limited to the floor surface
- Class II Damage—water damage exceeds the floor and has affected baseboards and other components
- Class III Damage—water damage exceeds the floor, has come from above, and/or the walls have been affected
- Class IV Damage—same as class III, but materials requiring specialized drying techniques have been affected
